To: Griswold, Hays[Griswold.Hays@epa.gov]
Cc: Allen Sorenson[Allen.Sorenson@state.co.us]; Kirstin Brown[Kirstin.Brown@state.co.us]
From: Way, Steven
Sent: Thur 7/30/2015 1:15:41 AM
Subject: Fwd: GK Exploration

From: "Matt Francis" <m.francis@erllc.com>
To: "Way, Steven" <way.steven@epa.gov>
Cc: "Petri, Elliott" <Elliott.Petri@WestonSolutions.com>
Subject: GK Exploration

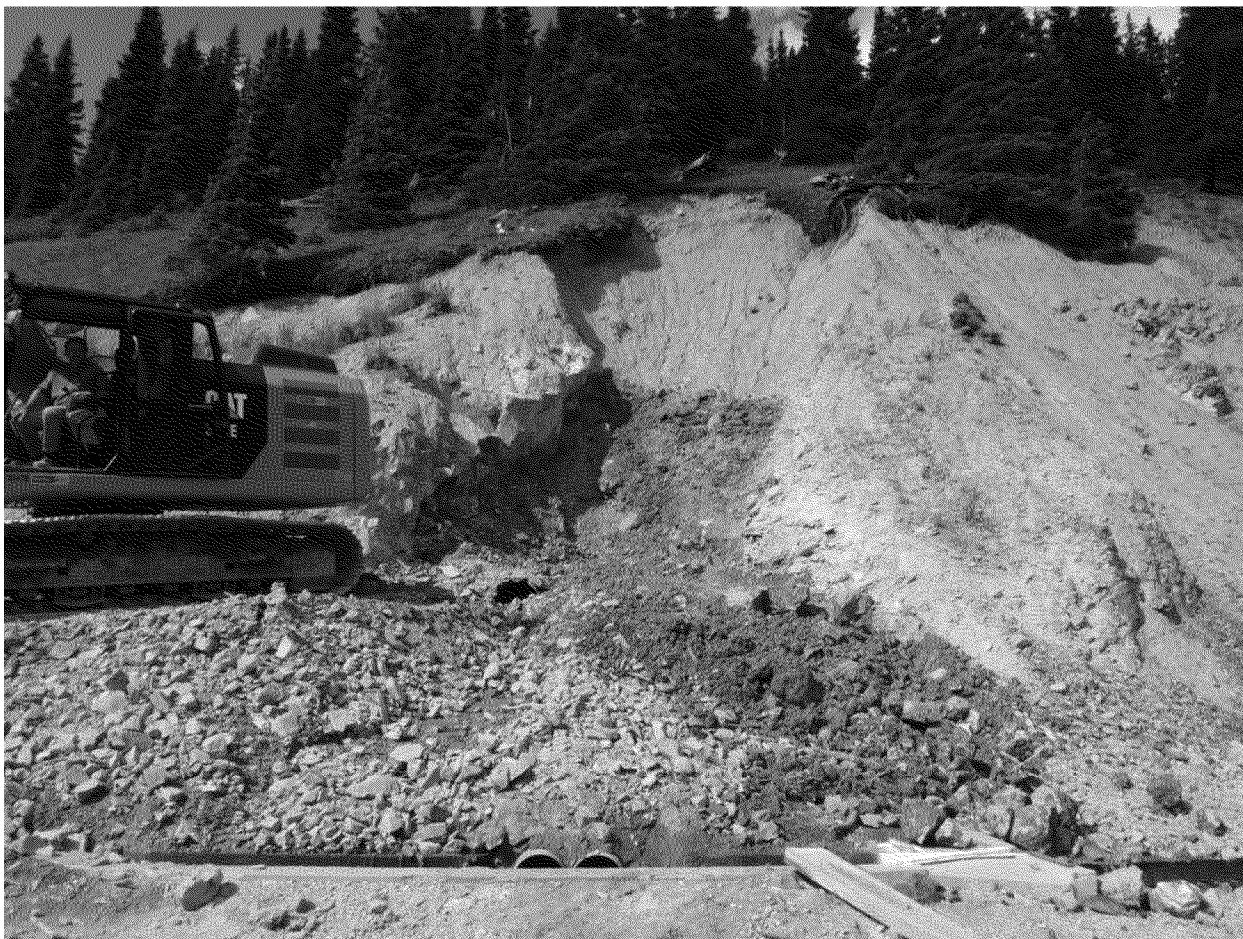
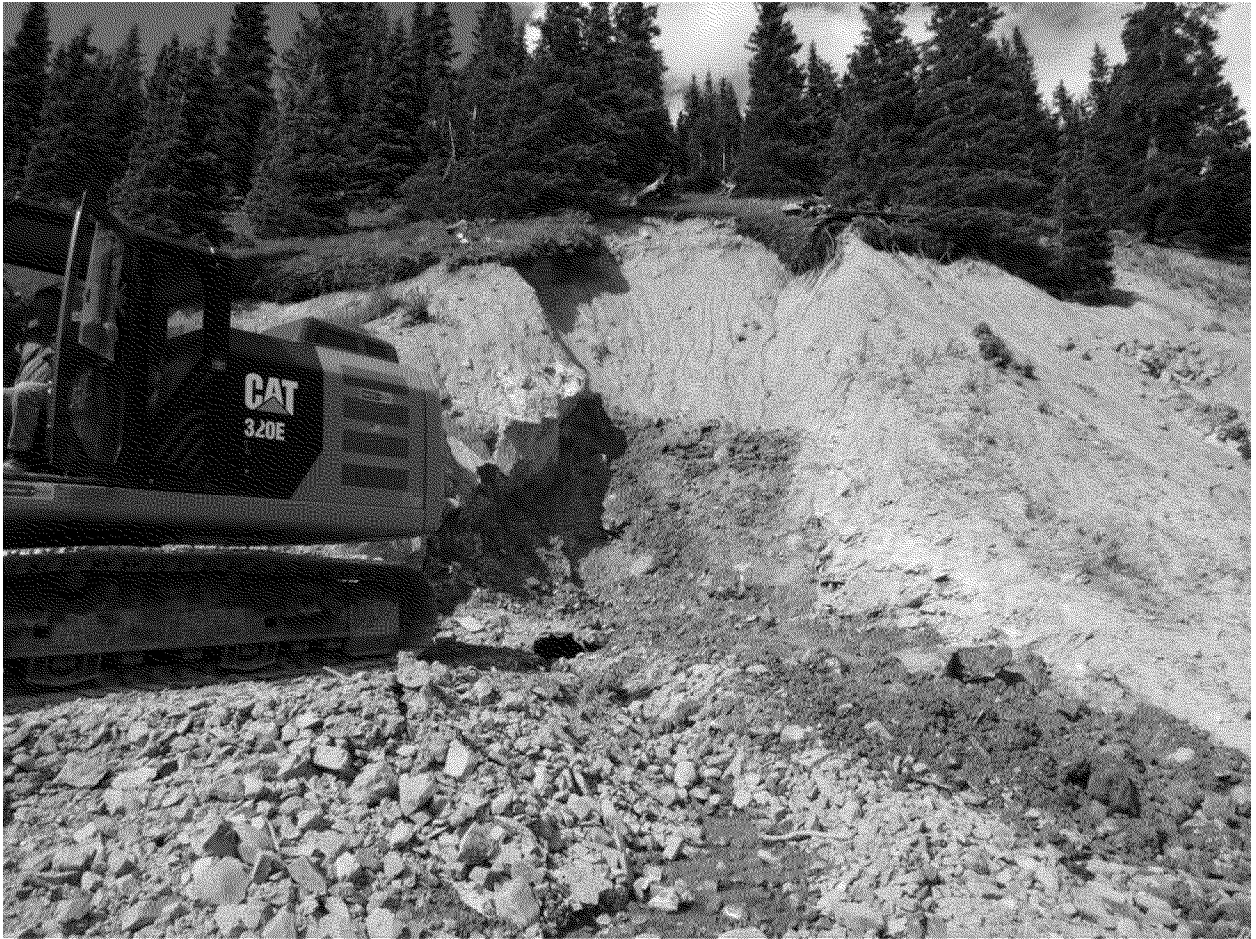
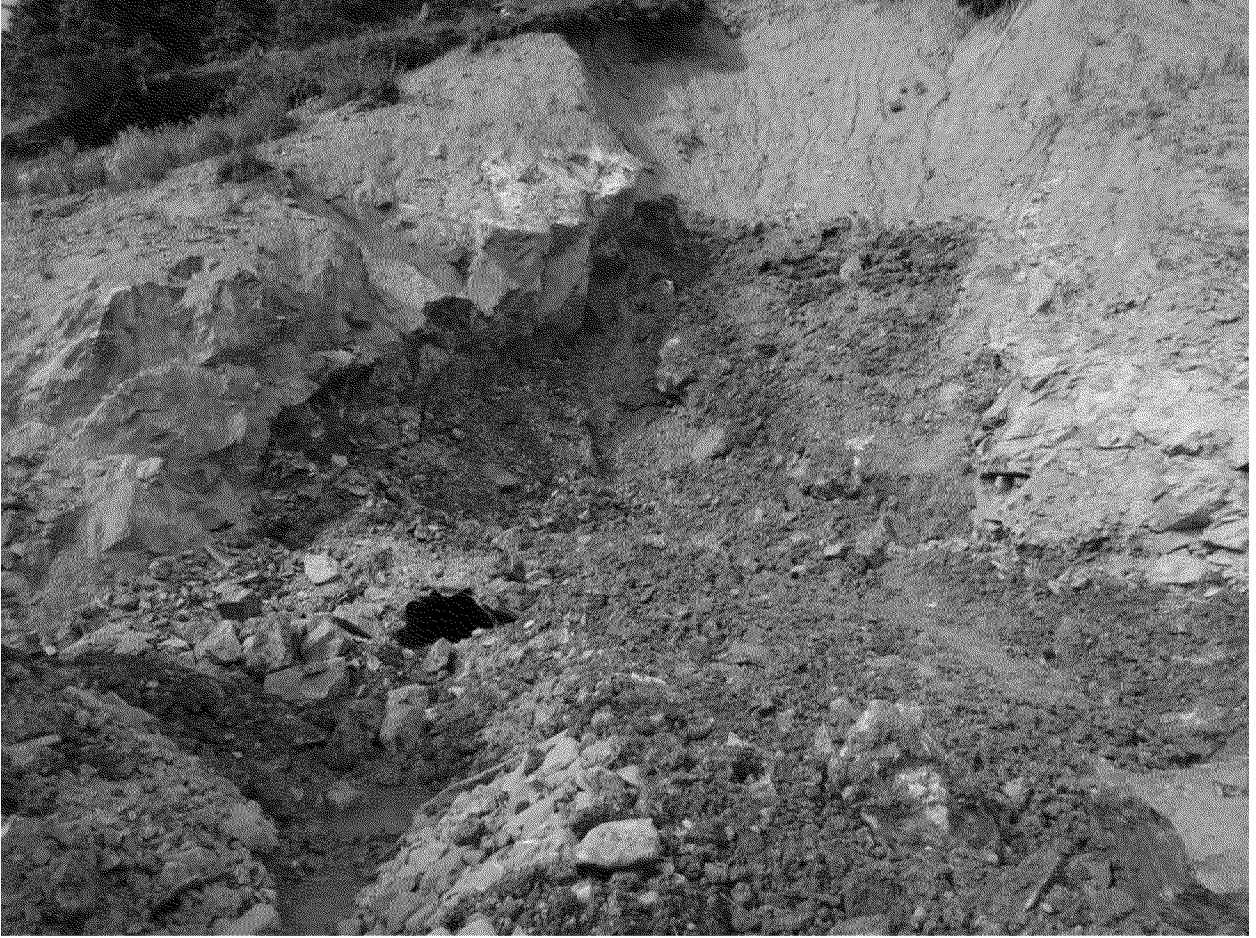
Attached are some pics after Frank did some removal above the outlet pipe. Not sure how the depth is represented in the pictures, but he removed as far as the excavator would reach without additional ramping or parking on the adit – roughly 15-20. The last picture is from inside the pipe looking back towards the crap behind it. Appears to be a rather short pipe to me. In general, all the rock above and around the portal seems to be fractured chunks that come apart easily. We will likely be going back significantly to find something solid to set the 10' portal pipe against. That means we need to look at how the hillside might need to be removed/sloped/secured/etc.
